ENGINEERING INVESTIGATIONS AT INACTIVE HAZARDOUS WASTE SITES

PHASE I INVESTIGATION

DOVER LF # 3
(Route 22, Eastside) Site No. 314032
Town of Dover Dutchess County

DATE: October 1989

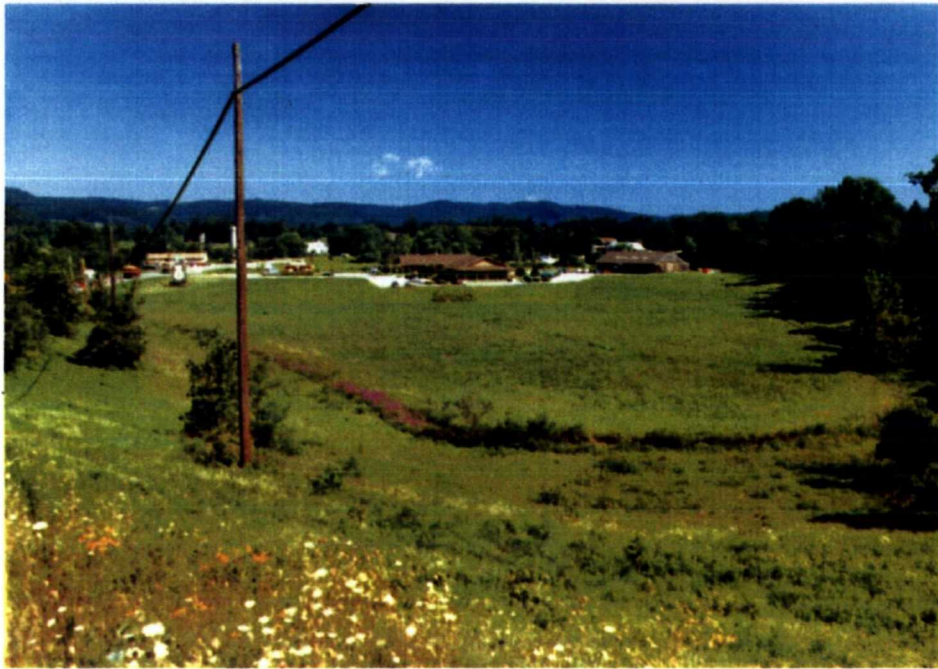
PHOTO 1-1 - From Route 22 looking north across the landfill at the Dover Village Shopping Center. Site is well vegetated, rather flat in the center, and a ditch runs along the bottom of the steep, downward slopes.

stressed vegetation was found. The property is a level, open field bordered by steep, upward slopes to the south, southeast, and southwest, and is easily accessible to the public (Photos 1-1 through 1-3).

The landfill was inspected on 1 September 1988 during a Phase I investigation by LMS under contract to NYSDEC. The property is a level, open field. It is well vegetated and bordered by steep upward slopes to the south, southwest, and southeast. A soil mound, ready to be spread, occupied the center of the former fill area. The owners hope to use the property for commercial (shopping center) purposes. No evidence of stressed vegetation was found (Photos 1-1 through 1-3; Ref. 1, Appendix A).

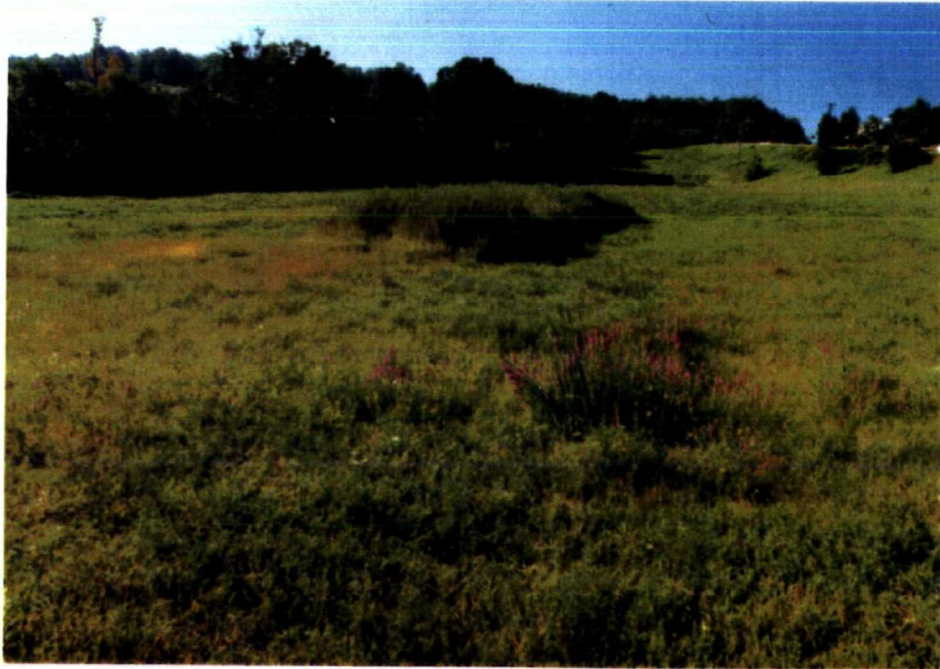
PHOTO 1-2 - From Dover Village Shopping Center parking lot looking south across the landfill. Notice dirt mound in center, steep upward slopes to the south, and treeline to the southeast.

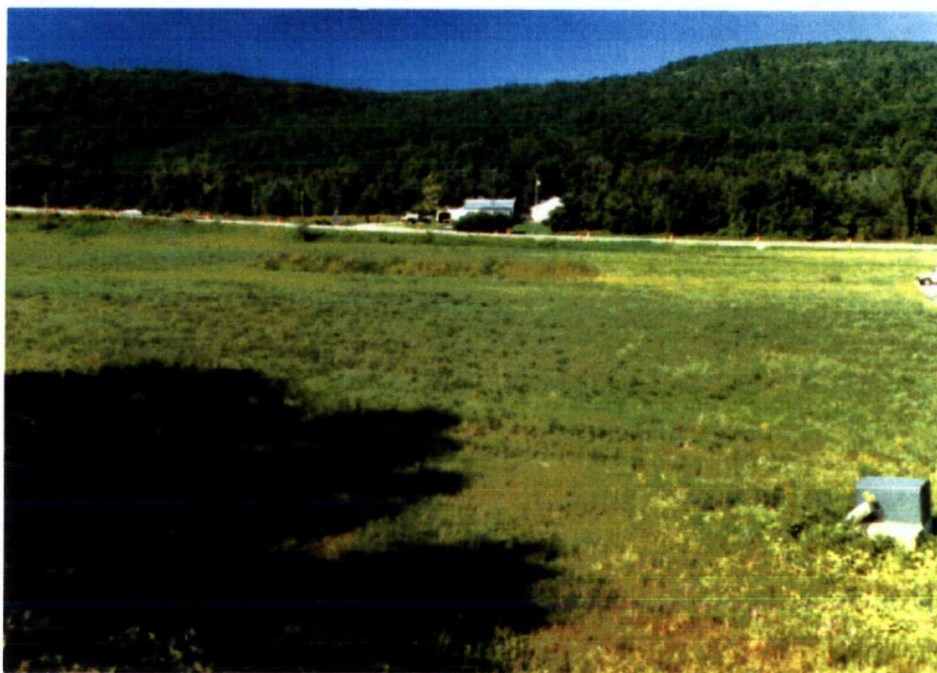
PHOTO 1-3 - Photograph was taken from the treeline adjacent to the railroad tracks looking west across the landfill at Route 22, West Mountain, and a commercial building.
